# Systematic Prevention of Construction Failures

Ilías Ortega

Institute for Technology Management

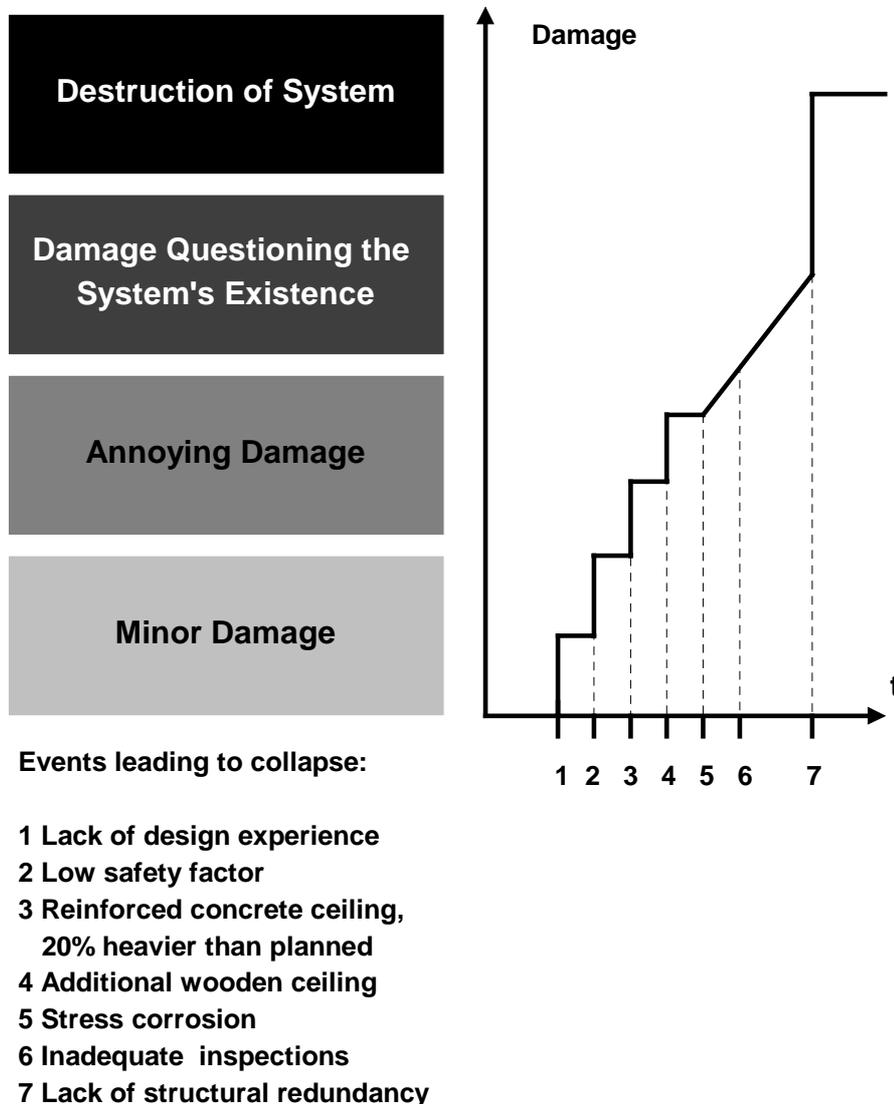
Two major effects triggered the final collapse of the swimming pool ceiling: Corrosion and simultaneous mechanical stress. On steel with at

least 12% chrome, a protective passive surface layer forms. It consists of oxidized chrome, with oxygen from the air or from the water. Unfortunately, a passive layer can be very easily damaged. The damage can result chemically, e.g. from chlorine in the air, or mechanically. Under tension loads, the chemically or mechanically caused injury to the passive layer can - like a notch - become the starting point of a crack. Due to the combined chemical and mechanical effects, the crack grows, and thus can lead to the fracture of a bar. Probably at the beginning of the collapse of the ceiling in Uster, some chrome nickel steel bars were so strongly damaged by stress corrosion, that they broke. The loads to be carried by the broken bars were then transferred to the neighboring bars. Some of them were already weakened by stress corrosion, and they promptly broke. Further bars tore due to overloading. This process repeated itself, until all bars had torn like a collapsing house of cards, and the ceiling fell down. The final mechanism that led to the collapse of the ceiling of the Swimming Pool Uster was lack of structural redundancy.

Figure 1 shows the different events contributing to its failure while using the damage level classification scheme proposed by Brauner (1990).

**Figure 1.** Events leading to the failure of the ceiling of the Uster indoor swimming pool using the damage level classification scheme proposed by Brauner (1990).

The collapse of the ceiling of the Uster indoor swimming pool was not caused solely by “material failure”, “selection of the wrong material” or “steel corrosion” but was caused by at least seven different factors. None of them by itself would have been sufficient to cause the accident. It was the unfortunate combination of all factors that precipitated the tragedy. The Uster ceiling collapse vividly illustrates the fact that, in many cases, the cause of failure cannot be attributed precisely to a single fact or

1. Inexperienced architects and engineers designing unconventional structures should seek the advice of an experienced, independent architect and engineer. A peer-review of the project design should also be considered.
2. Unconventional structures require a monitoring plan (e.g. of deformations) for the construction and operational stage. Thus damage to the structure can be noticed before it is too late. In particu-
